# A Project Report for the repairs & restoration at Blocks A & B

## Existing Ground & First floor: Structural Audit & Concerns

M/S Devang Sutaria and Associates have audited the structure and the following are a few points requiring interventions.

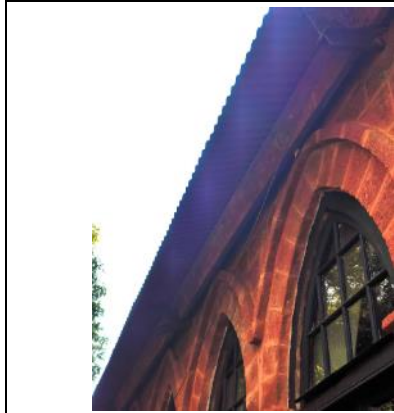
Brackets supporting external purlin are corroded. The wooden rafters and purlins over Games room and Dining block zone 2 shall need repairs/ replacement.

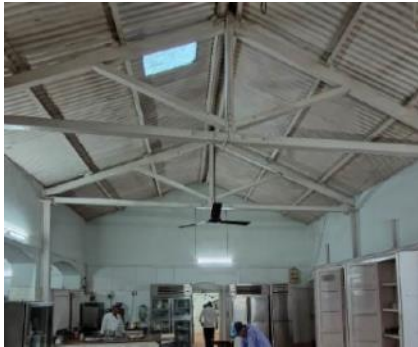
Damage to walls. Leakages in walls at interface with roofing etc observed. Localised efflorescence observed.

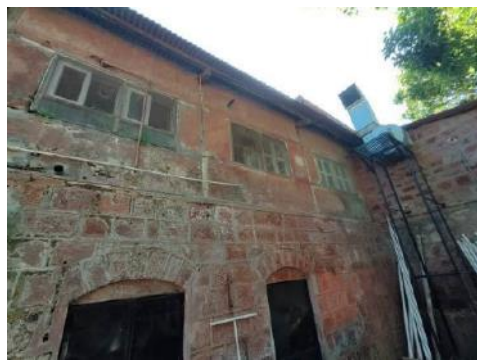
Distress in some wall, lot of moss formation, leakages and localized cracking observed in this area. The lower part of the structure is in laterite while upper part in bricks with exposed wooden columns. A Homogenous laterite wall structure is desired.

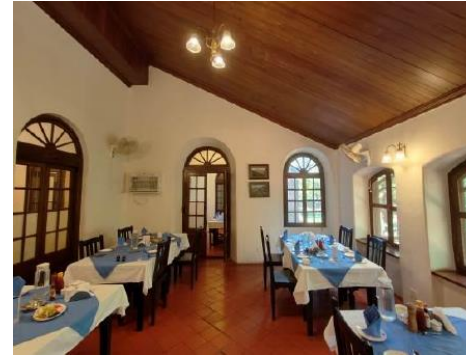
Some efflorescence, some damage to flooring and deflection of false ceiling is observed.

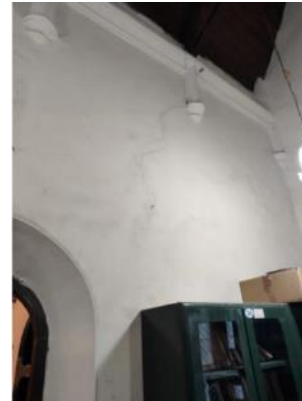
Some cracks along door opening in wall observed in Library

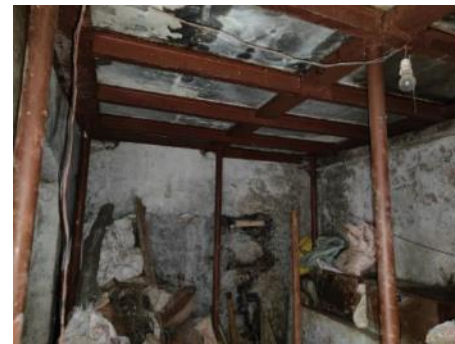
Leakages, efflorescence and corrosion of supporting structure to kitchen floor observed. Severe leakages in floor and wall observed due to kitchen wet areas and probable plumbing issues. Moss formation. Recommend to get rid of Mild steel floor structure and cast an RCC structure for the floor only.

*Removing the Mild steel structure in the store rooms below the kitchen block and structurally casting a new RCC slab*

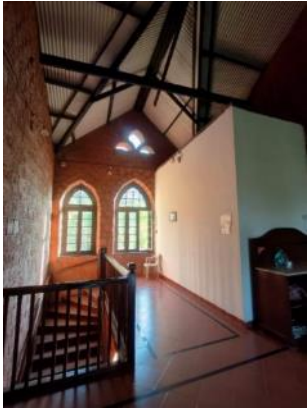
Some damage to hip rafter at joint observed. Gaps at junctions of windows and wall observed.

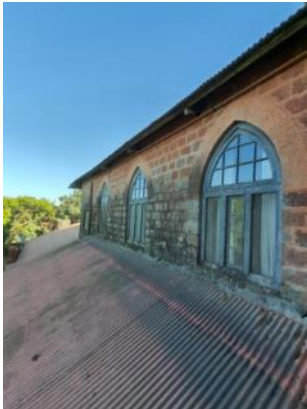
Damaged wata/ warped purlin/ moss formation on wall surface observed. Efflorescence in walls observed

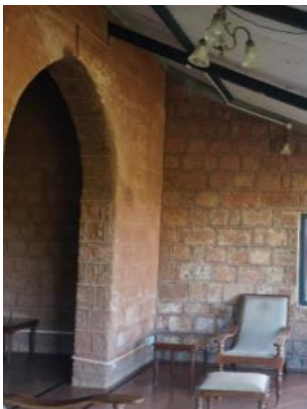
Efflorescence in walls observed

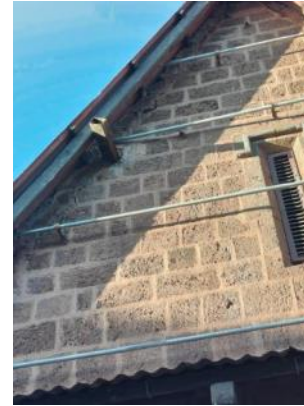
Damage to top of wall observed. Cracking and opening of joint observed.

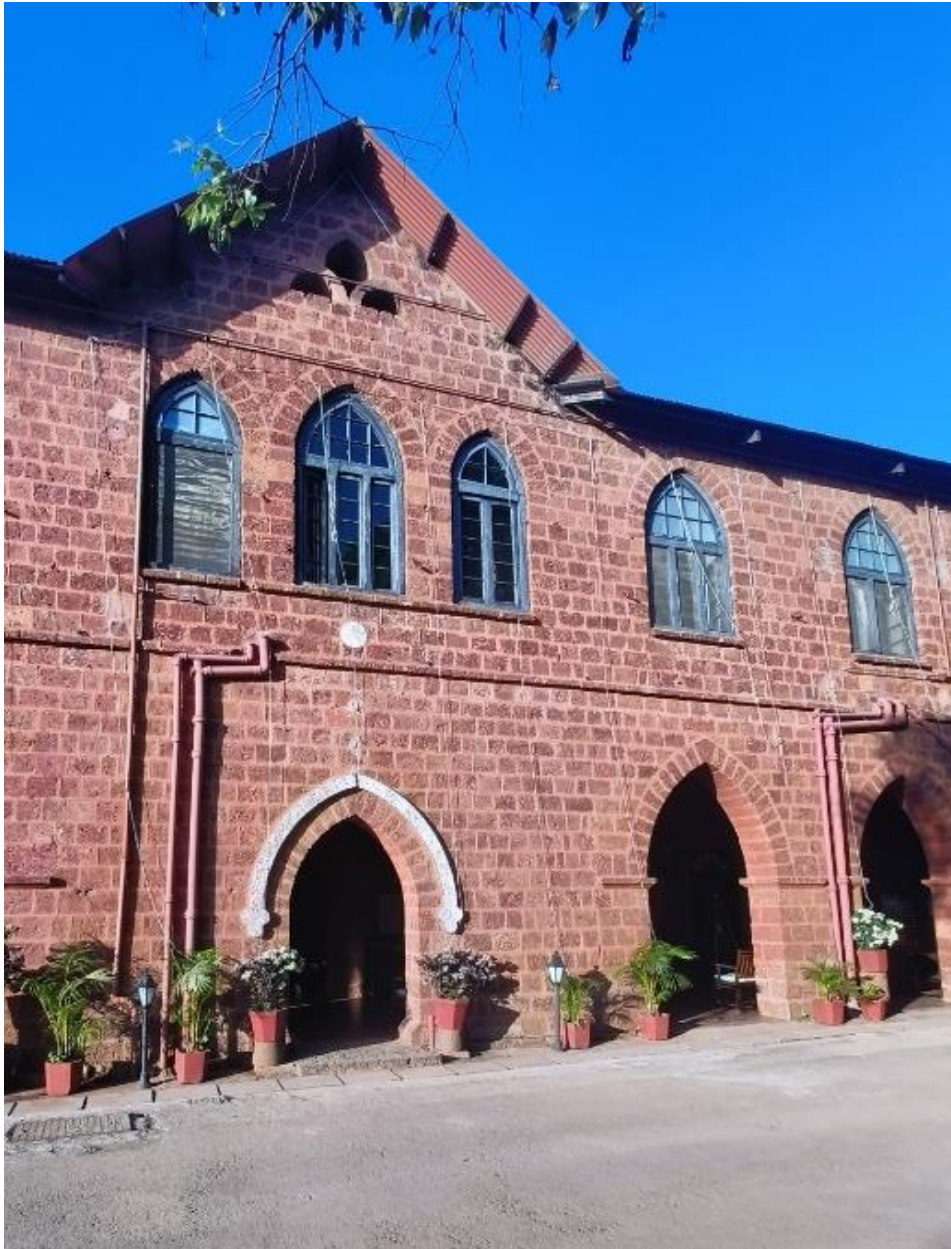
*Note the existing stone ware and GI pipes on the main facade*

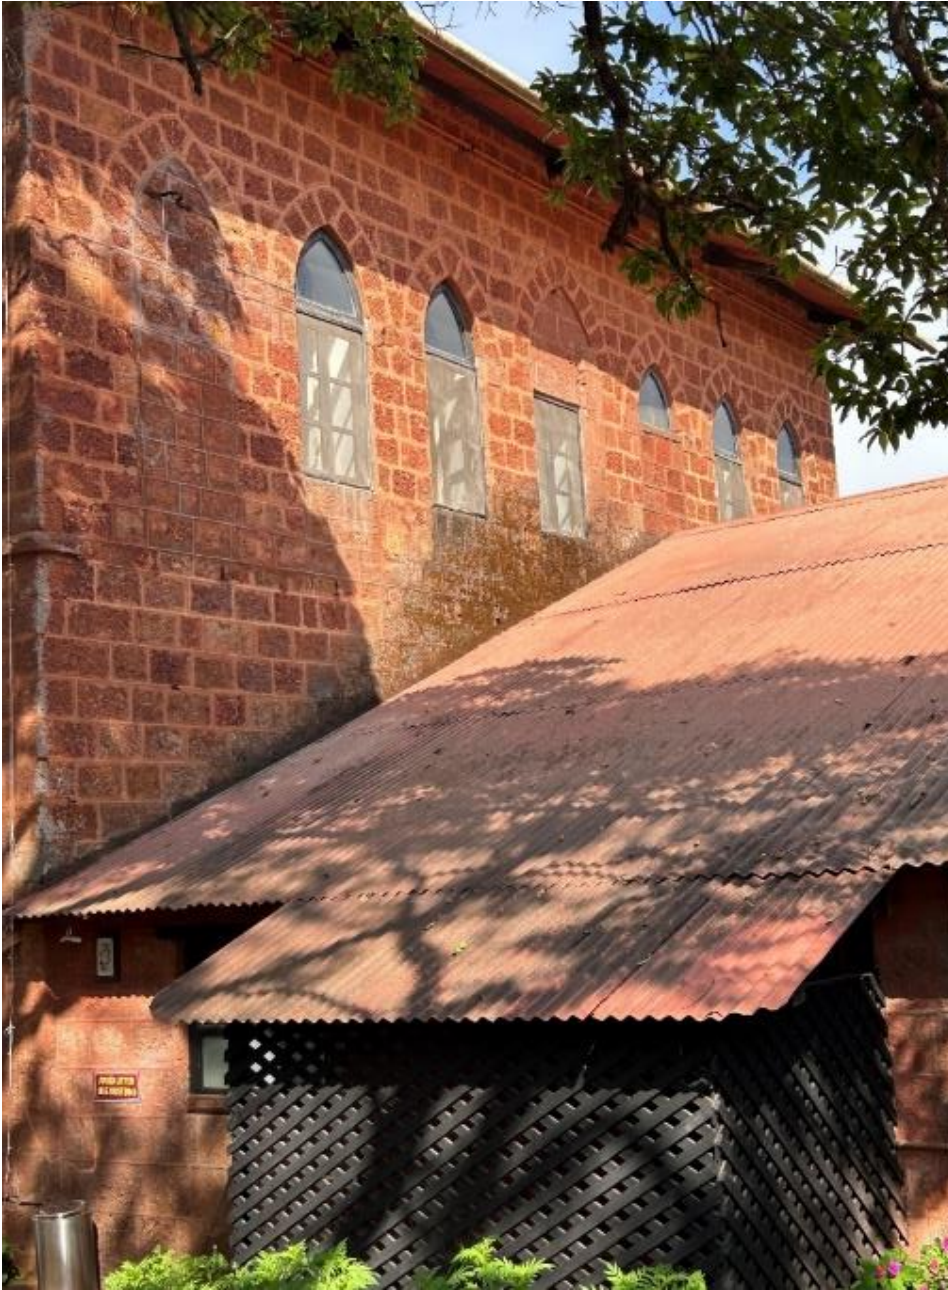
*Note the window which is closed up on the top left side of Room A2*

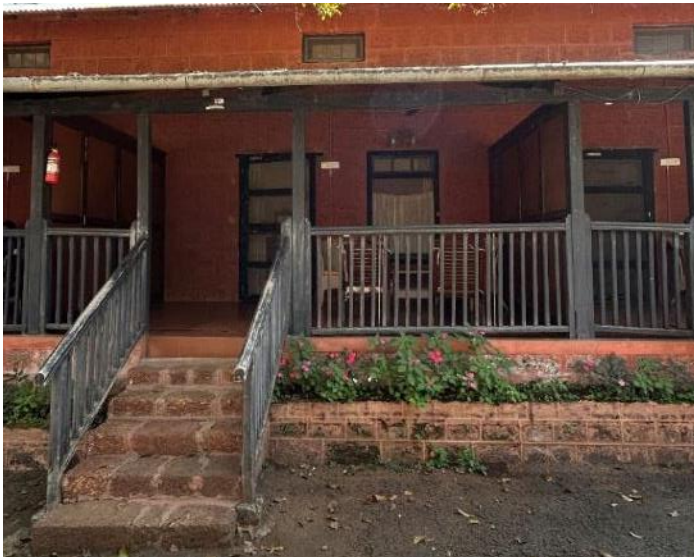
*Existing railing with Wooden Balustrades*
