# A Project Report for the repairs & restoration at Blocks A & B

## Existing Ground & First floor: Structural Audit & Concerns

M/S Devang Sutaria and Associates have audited the structure and the following are a few points requiring interventions.

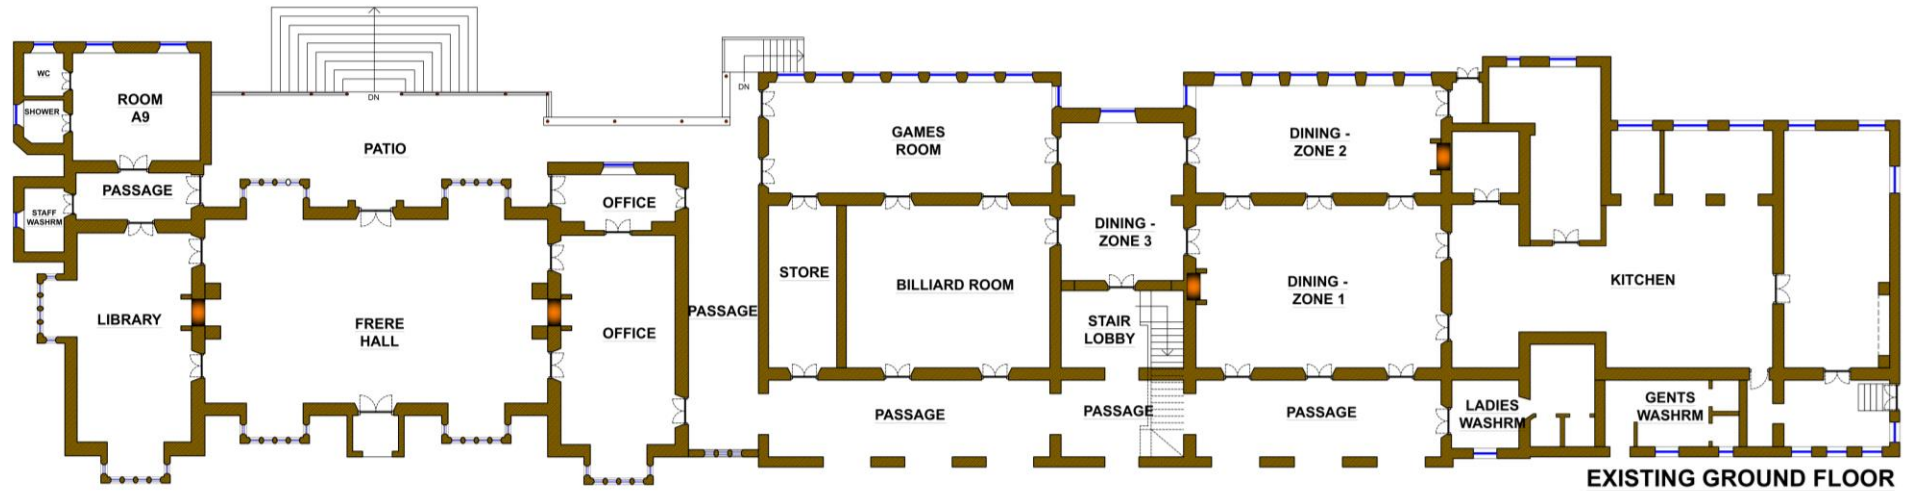
## Existing Ground floor: Design Concerns

The existing ground floor block exhibits following design concerns.

1. Efficiency, hygiene and Modernization of Kitchen is desired.
2. Dilapidated, uneven & damaged flooring in Dining rooms and passages.
3. Damaged windows along the north side façade and washrooms.
4. Lack of efficient lighting; rooms look dull. Heritage character needed.
5. Haphazard electrical cables running along the north façade & passage besides office.
6. Old cables and wires pose an electrical hazard.
7. Old stoneware pipes of first floor bathrooms routed along the front façade.
8. Damaged wooden false ceiling in Games room, Dining Zone 2 & Patio.
9. Heritage design and aesthetics in Room A9 is desired.
10. Heritage design and aesthetics in Library is desired.
11. Lack of accessibility for physically challenged and senior citizens to first-floor rooms.

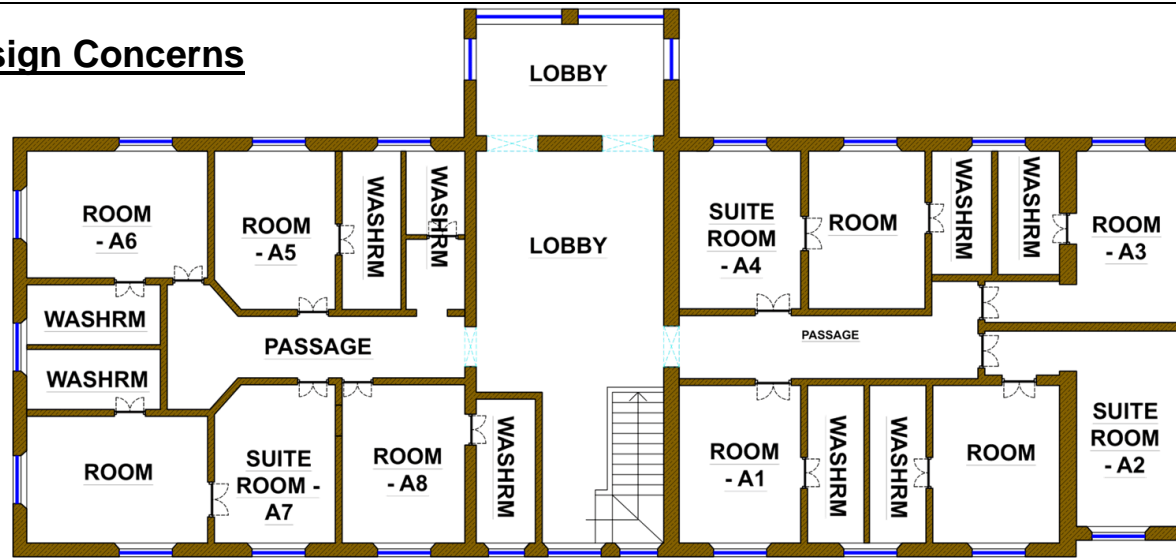
## Existing First floor: Design Concerns

The existing first floor block exhibits following design concerns.

1. Washroom A8 projected into the original lobby space and is distorting the original heritage character of the building.
2. Existing vitrified tiles in rooms, washrooms and passages are not of heritage character.
3. Damaged exterior windows on all sides.
4. Lack of sound insulation between rooms and washrooms.
5. General heritage style lighting of all rooms is desired.
6. Old stoneware pipes of first floor bathrooms currently routed along the front façade.
7. Heritage design and aesthetics in all rooms is desired.
8. Lack of accessibility for physically challenged and senior citizens to the first-floor rooms.

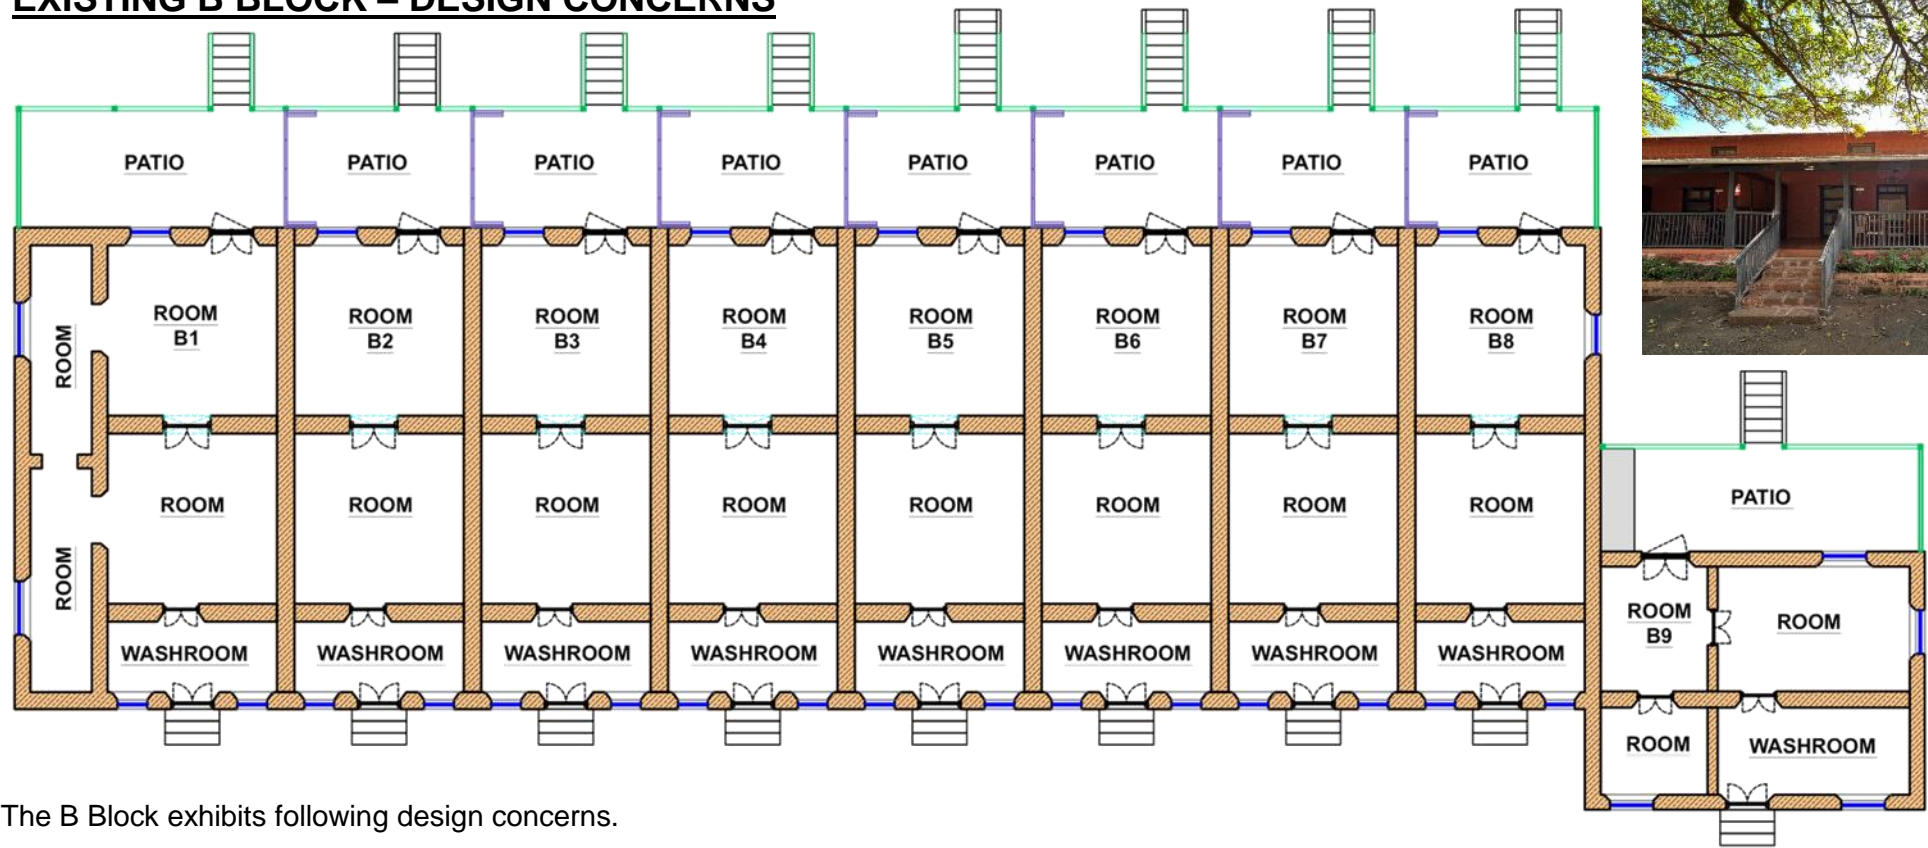
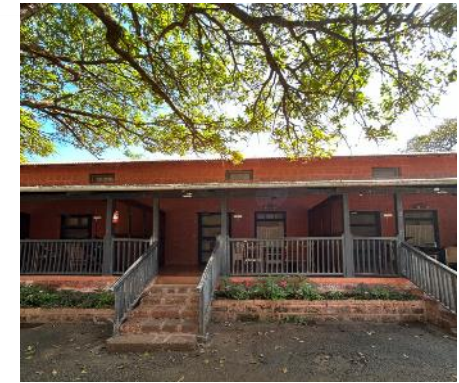
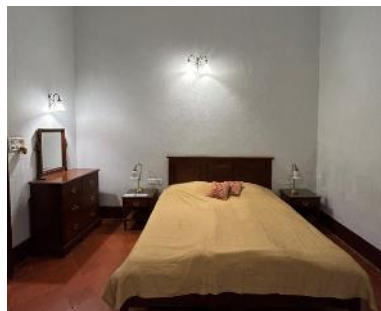
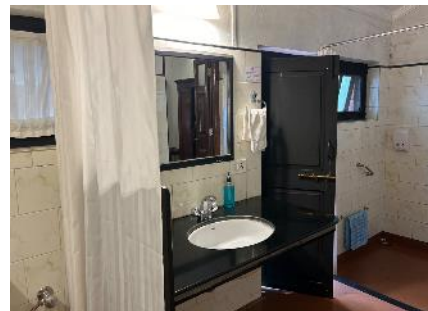
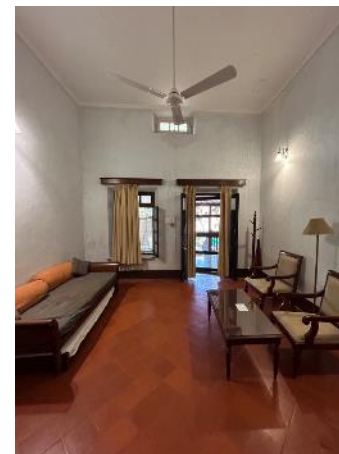
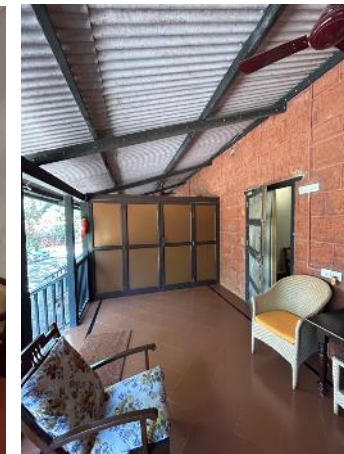
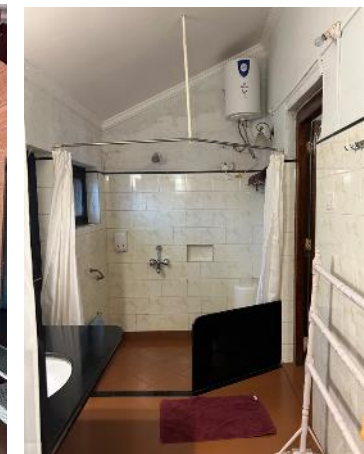
## EXISTING B BLOCK – DESIGN CONCERNS

The B Block exhibits following design concerns.

1. Dilapidated, uneven & damaged flooring in rooms and passages.
2. Lack of efficient lighting; rooms look dull. Heritage character needed.
3. Heritage design and aesthetics in Rooms is desired.
4. The wooden railing and its balustrades are broken and damaged.
5. Doors & windows need repairs

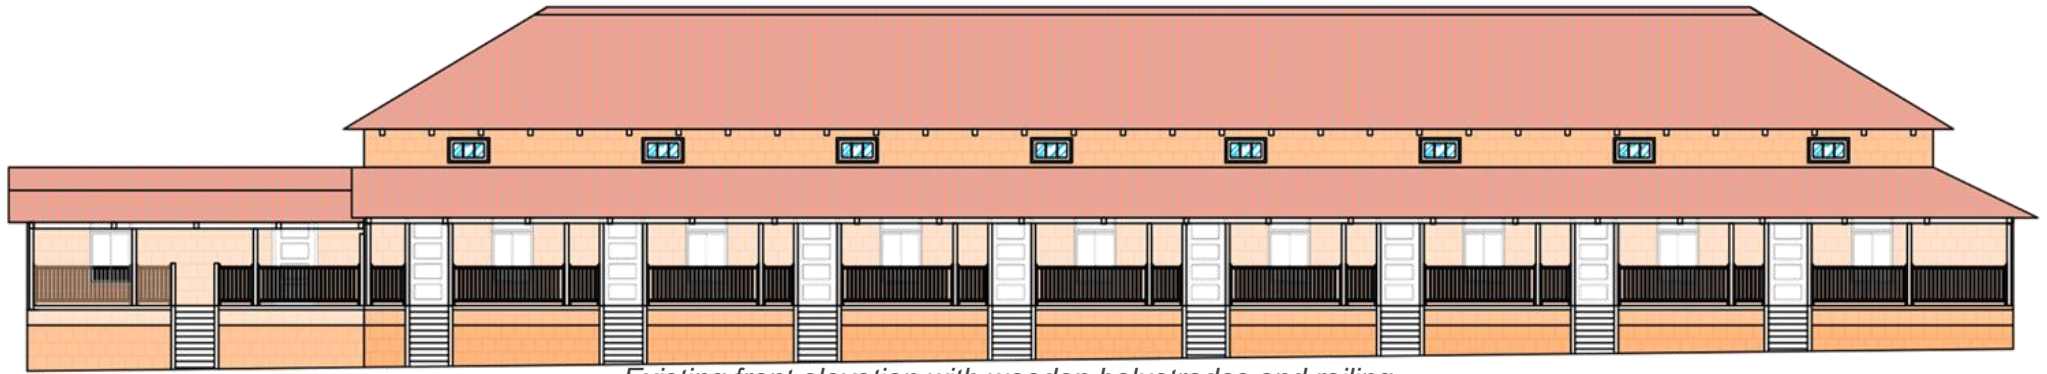
*Existing front elevation with wooden balustrades and railing*
